FINAL TECHNICAL REPORT

FIELD DEMONSTRATION OF THE HOT GAS DECONTAMINATION SYSTEM

Report No. SFIM-AEC-ET-CR-95011

February 1995

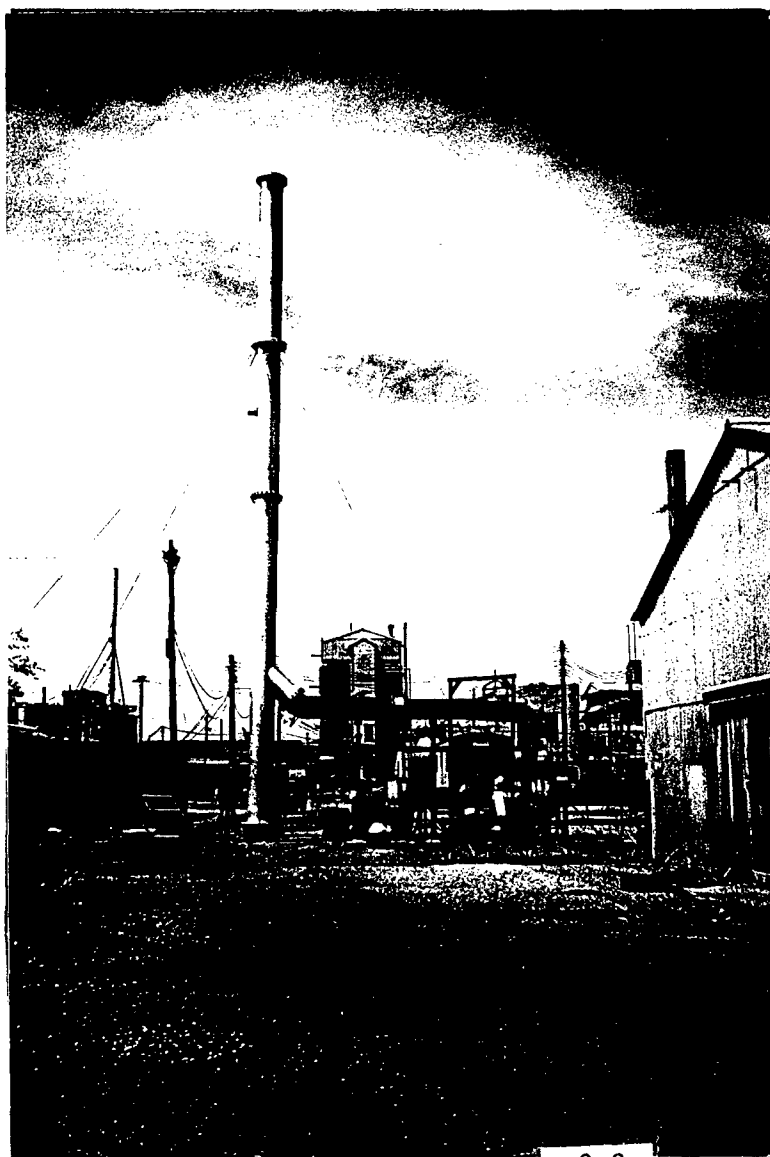
STACK ASSEMBLY
